# 2026 BEAR TREE FARMS SEDIMENT INVESTIGATION REPORT

PREPARED FOR:  
Bear Tree Farms HOA

PREPARED BY:  
ILM ENVIRONMENTS

June 09, 2026

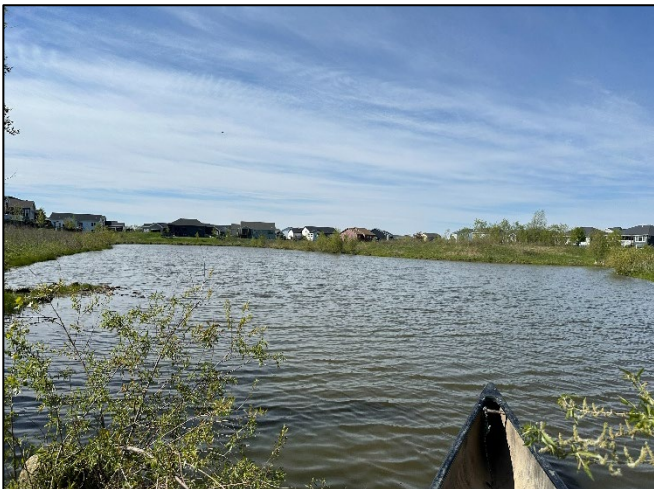
- The surface of Pond 1 was mostly clear, with <5% of the pond's total surface area covered with algae growth that was confined to the shorelines (Photo 1).

**Photo 1.** Pond 1, facing south

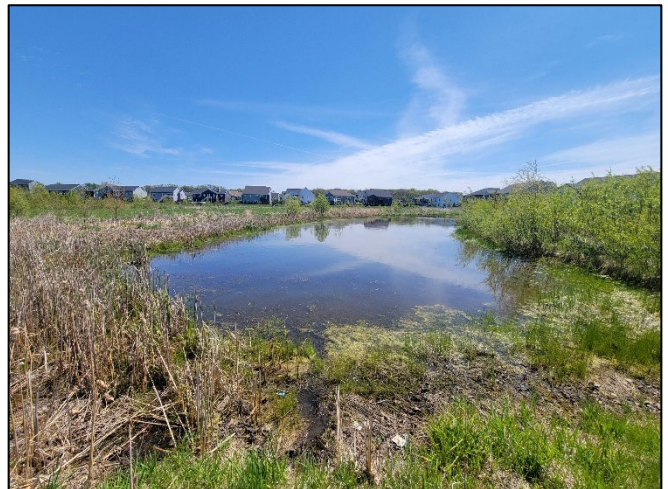
- Ponds 2 and 3 had clear surfaces, with <5% of their respective surface areas covered in Filamentous algae, Oscillatoriales mats, and Common Duckweed (*Lemna minor*) (Photos 2 and 3).

**Photo 2.** Pond 2, facing southeast

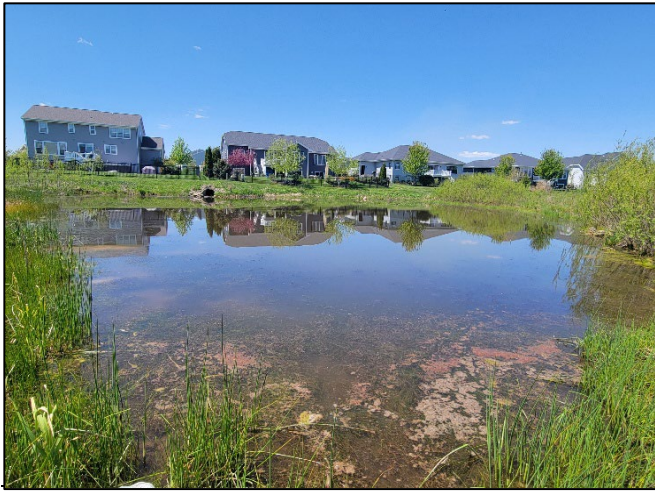
**Photo 3.** Pond 3, facing west

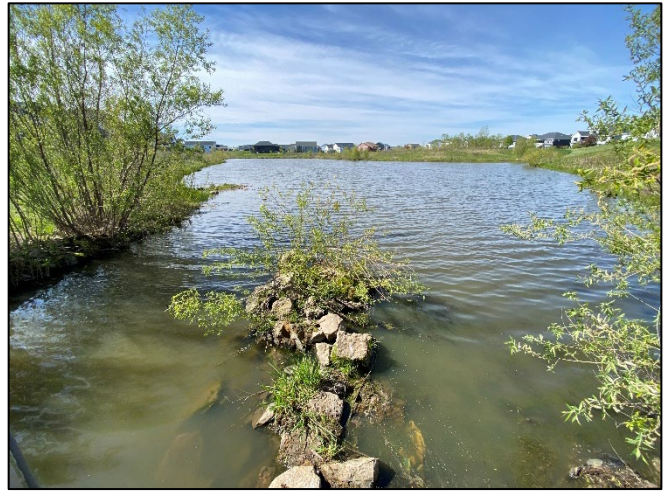
- A long compact sandbar extends from a projection of rocks on Pond 1. Historical imagery shows that this was a terrestrial separation during new pond installations in 2020-2021 before the ponds were filled into the single 1.9-acre basin that is currently present (Appendix C).

**Photo 4.** Rocky projection at inflow culvert, Pond 1

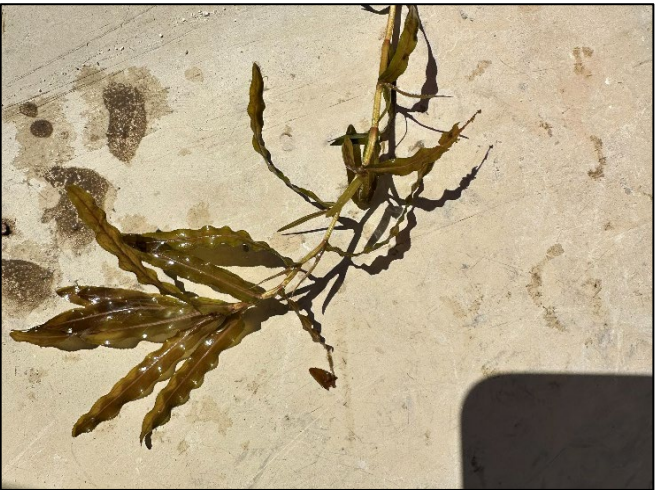
- Sediment accumulation in Pond 1 is thickest adjacent to the sandbar.
- Sediment composition in all three ponds was silty, with a rock bottoms.
- Aquatic plants observed included invasive Curly-leaf Pondweed (*Potamogeton crispus*) (Photo 5). Native species included Horned Pondweed (*Zannichellia palustris*), Sago Pondweed (*Stuckenia pectinata*), and American Pondweed (*Potamogeton nodosus*).

**Photo 5.** Invasive Curly-leaf Pondweed (*Potamogeton crispus*)

Invasive Curly-leaf Pondweed is present in all three ponds. Managing it is important to control the spread of this invasive plant. Biotic decay from large-scale aquatic herbicide treatments can contribute to the accumulation of nutrient-rich sediment. Managing the invasive Curly-leaf Pondweed early in the season with targeted preventative treatments can greatly reduce the need for additional aquatic herbicide applications later in the season. Specific herbicides are designed to inhibit the early-season growth of this invasive species and allow for native species to grow later in the season. Allowing for native aquatic growth, as seen during the ILM visit, can sequester nutrients that would otherwise be used to fuel algae blooms.

Testing for phosphorus levels in water and sediment can determine whether the ponds have an overabundance of nutrients that fuel plant and algae growth. Phosphorus levels can be reduced by applying products that render it unavailable to vegetation. Clay pellets, along with a rare earth mineral (lanthanum), bind with reactive phosphorus in the water column as it is applied. The clay then sinks to the sediment, where it continues to bind with phosphorus as it is released from the sediment. It is recommended that this be done following any large-scale herbicides, as the resulting biotic decay can quickly raise phosphorus levels in the pond. Nutrient deactivation bags can also be placed at the large inflow of Pond 1 to capture some of the upstream phosphorus before it enters the pond.

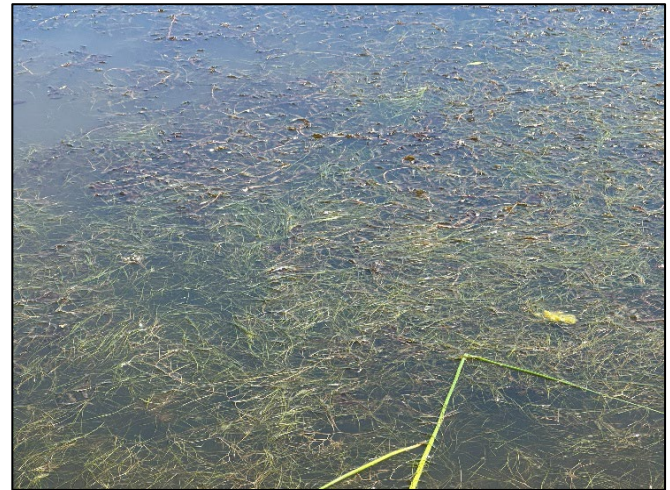
- Plant growth was very dense throughout Pond 2 (Photo 5).
- Leopard frogs at Pond 2 are a species indicative of generally good water quality.
- Mild to moderate erosion was visible along the shorelines of all ponds and was most apparent at Pond 1 (Photos 7-9).

**Photo 6.** Dense native plant growth in Pond 2

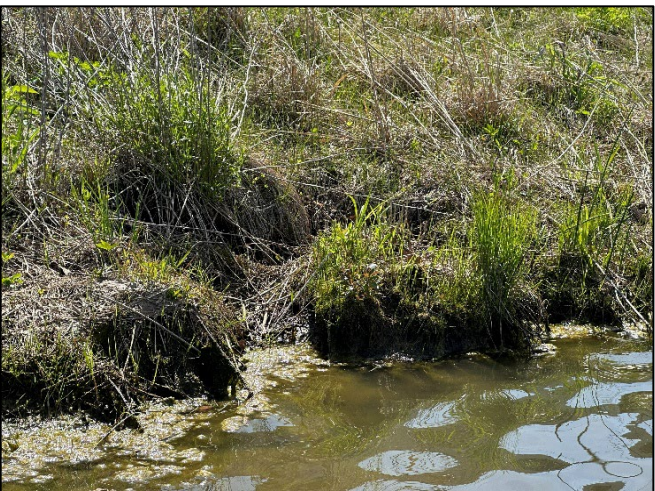
**Photo 7.** Shoreline erosion facilitates algae growth, Pond 1

Shorelines around all three ponds were exhibiting signs of mild to moderate erosion. Erosion adds sediment to the ponds, decreasing their functional lifespans and increasing the nutrients available to fuel algal blooms and the growth of weedy aquatic flora. Additionally, erosion washes away property that cannot be restored. Management of shorelines and increased stabilization will reduce this loss of property and curb the stressors of external nutrient loading on the ecosystem, often improving the overall aesthetic of the pond.

Expanding and restoring the current natural buffer with biodiverse deep-rooted native species can help reduce the impacts of erosion by stabilizing the surrounding soil. This will require stewardship to remove and manage the invasive and nuisance terrestrial growth among native flora in the current buffer. Further installation of emergent shelves along the shoreline and in shallow areas can benefit the area by stabilizing sediment in the water, minimizing the effects of wave erosion and fluctuating water levels. These plants can also sequester nutrients (phosphorus and nitrogen) in stormwater runoff before they enter the pond and contribute to algae blooms. Tall native plant buffers also deter geese, which contribute to nutrient loading through their waste, while encouraging the presence of other native wildlife, including pollinators, songbirds, and fish in emergent buffers.

Biotechnical stabilization may be necessary in areas exhibiting more severe erosion, which were primarily located along Pond 1. Stabilizing eroding shorelines should take priority to achieve the greatest reduction in pond sedimentation following any potential dredging projects. This will increase the longevity of the dredge by addressing one of the primary sources of sediment loading. Different options for biotechnical stabilization exist based on the severity of erosion.

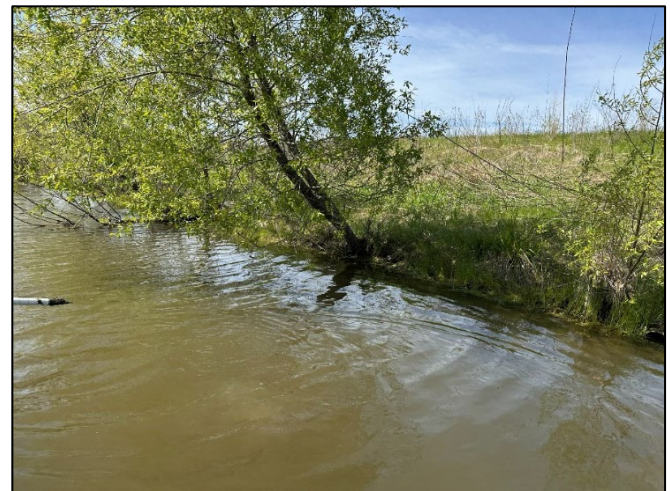
**Photo 8.** Shoreline tree eroding into Pond 1

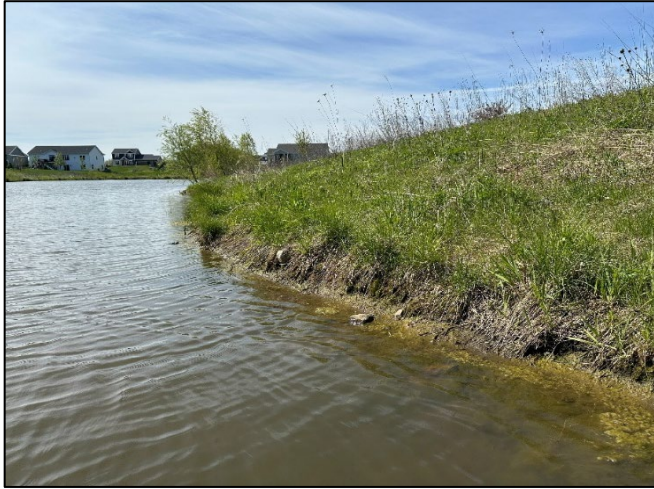
**Photo 9.** Moderate erosion exposing soil along the shore

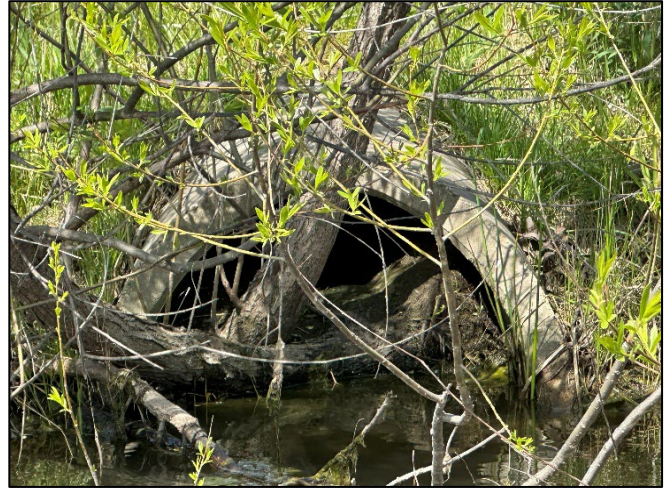
- A tree is growing in the West culvert at Pond 1 and should be removed before it causes structural damage (Photo 10).
- The inflow culverts at Ponds 2 and 3 have been partially impacted by sediment accumulation, but are still functional.

**Photo 10.** Tree growing in Pond 1 West Culvert

Maintaining the functionality and structural integrity of the culverts will allow water to flow in and out of the basins as originally engineered, reducing the capacity for flooding, erosion from water fluctuations, or stagnation that encourages algae growth. Removing the tree from the west culvert on Pond 1 is highly recommended to preserve its functionality before additional damage to the structure occurs.

Monitoring culverts, especially after rain events, is important to ensure flow is not impeded. This will help mitigate the erosion caused by fluctuating water levels by reducing the intensity and duration of said fluctuations.

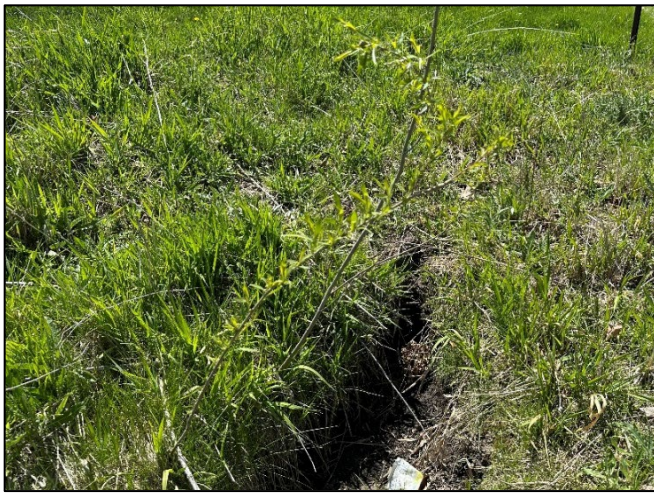
- Ditches are being created along the shorelines where stormwater and resident pipe infrastructure flow through the buffers (Photo 11).
- Buffers around the ponds were naturalized, composed of native and non-native plants, including turfgrasses, invasive Reed Canary Grass (*Phalaris arundinacea*), and Willows (*Salix spp.*) (Photos 12-14)

**Photo 11.** Ditches created in the buffers by pipes

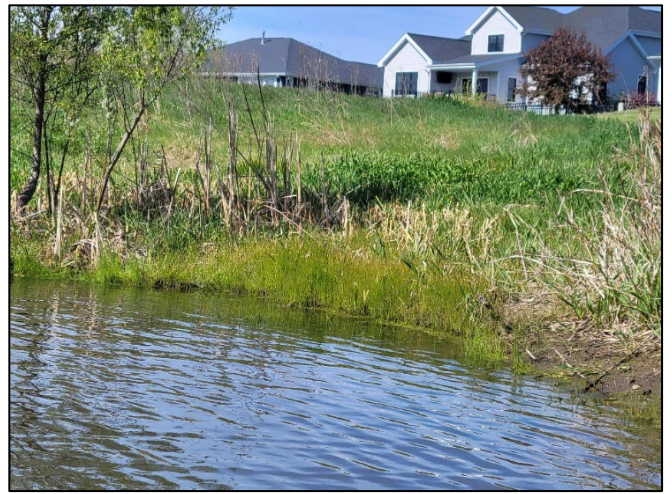
**Photo 12.** Representative shoreline of Pond 1

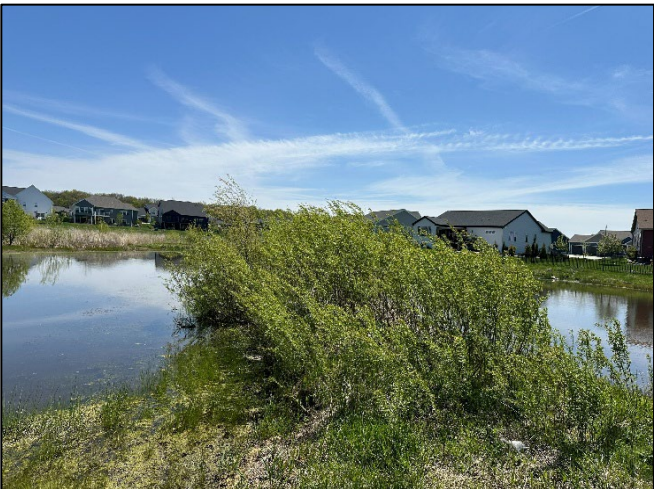
**Photo 13.** Vegetation separating Ponds 2 and 3

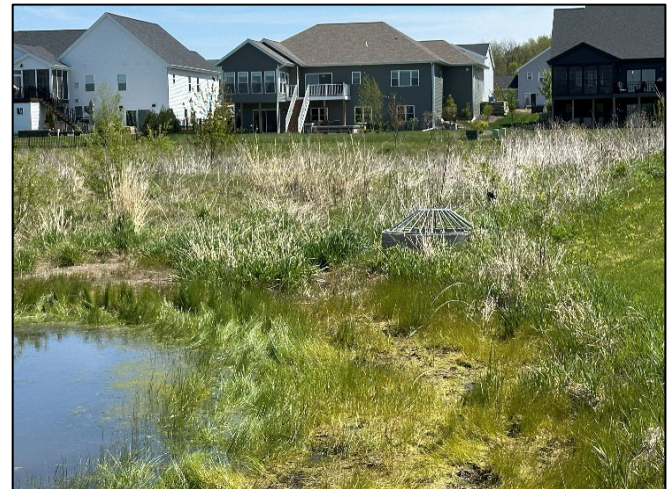
**Photo 14.** Naturalized buffer around Pond 2

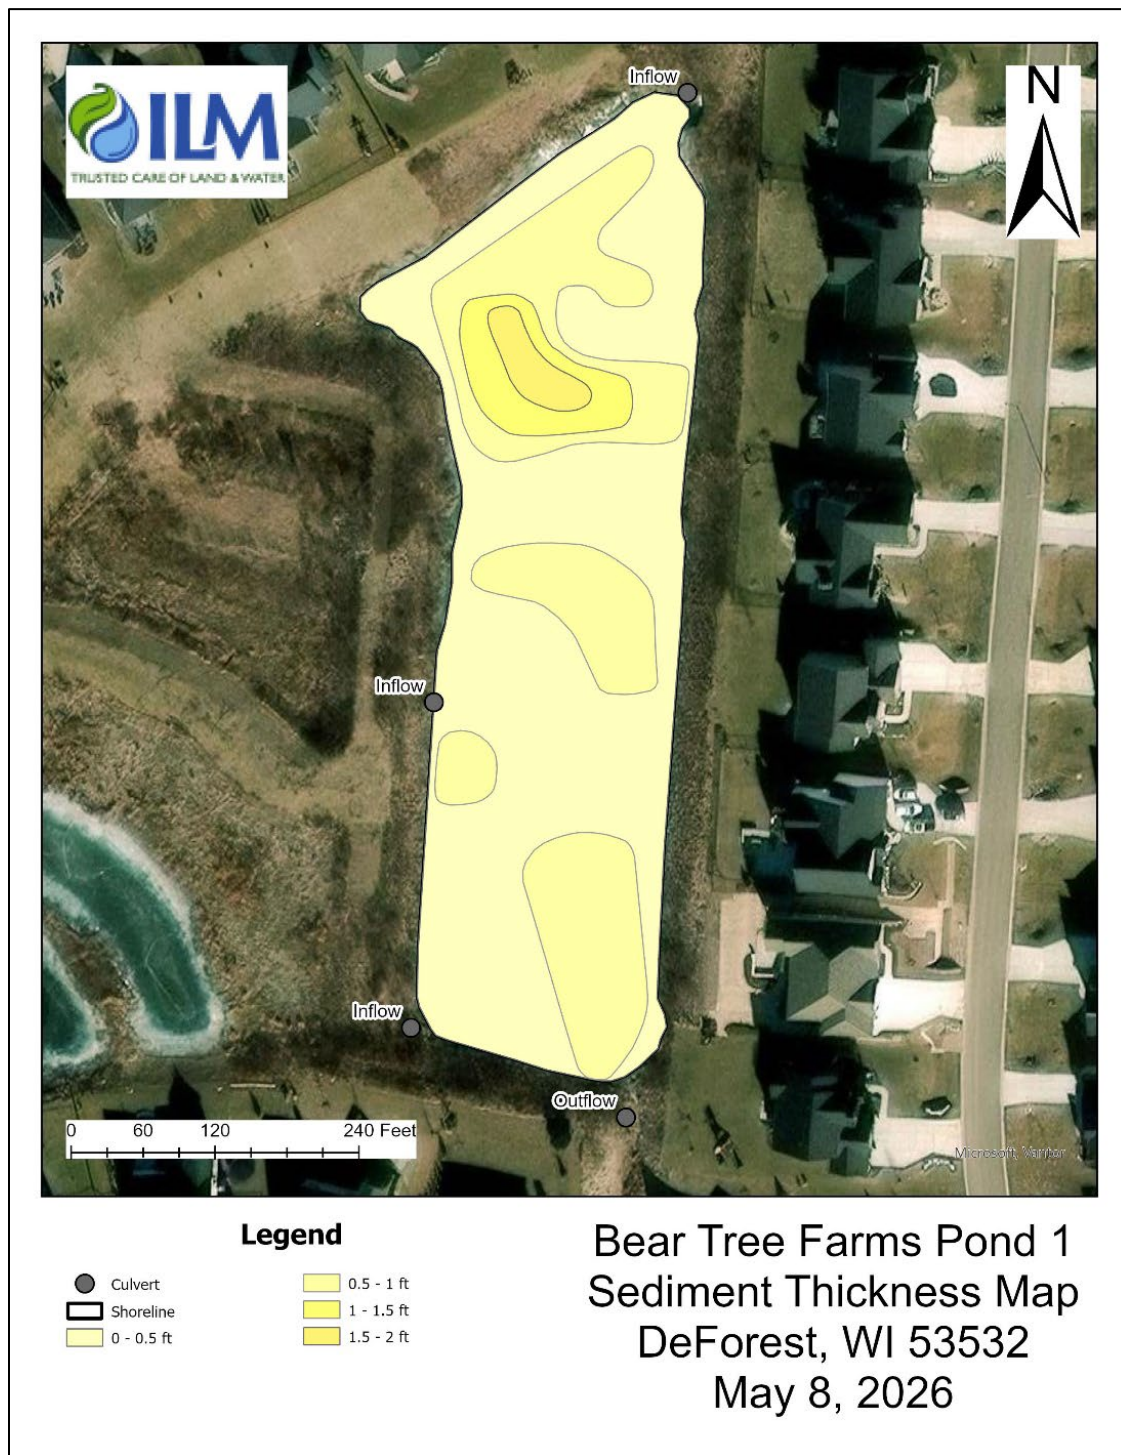
**Figure 3.** Sediment thickness survey map of Bear Tree Farms Pond 1

Bear Tree Farms Pond 1 is 13% full of sediment (Table 1). The maximum sediment thickness recorded was 1.9 feet. The average water depth was 3.2 feet. If the entire area were dredged of all sediment, around 1,489 cubic yards, the average water depth would increase by about 0.5 feet. This would increase the basin's volume by approximately 0.9 acre-feet, or 309,558 gallons at NWL.

The ponds at Bear Tree Farms range from 13-29% full of sediment, indicating that **full pond dredging is not recommended at this time for ponds 1 or 3** based on how much sediment is present. However, Pond 2 is very close to 30% full of sediment, so dredging may be considered in the future to prolong the basin's functionality. It should be noted that dredging will not stop sediment accumulation from erosion, biotic decay, or upstream deposits. Partial dredging options exist for areas of high sediment accumulation, but since these areas are located along more severe erosion zones, it is recommended that the shorelines are repaired first before any partial dredging takes place.

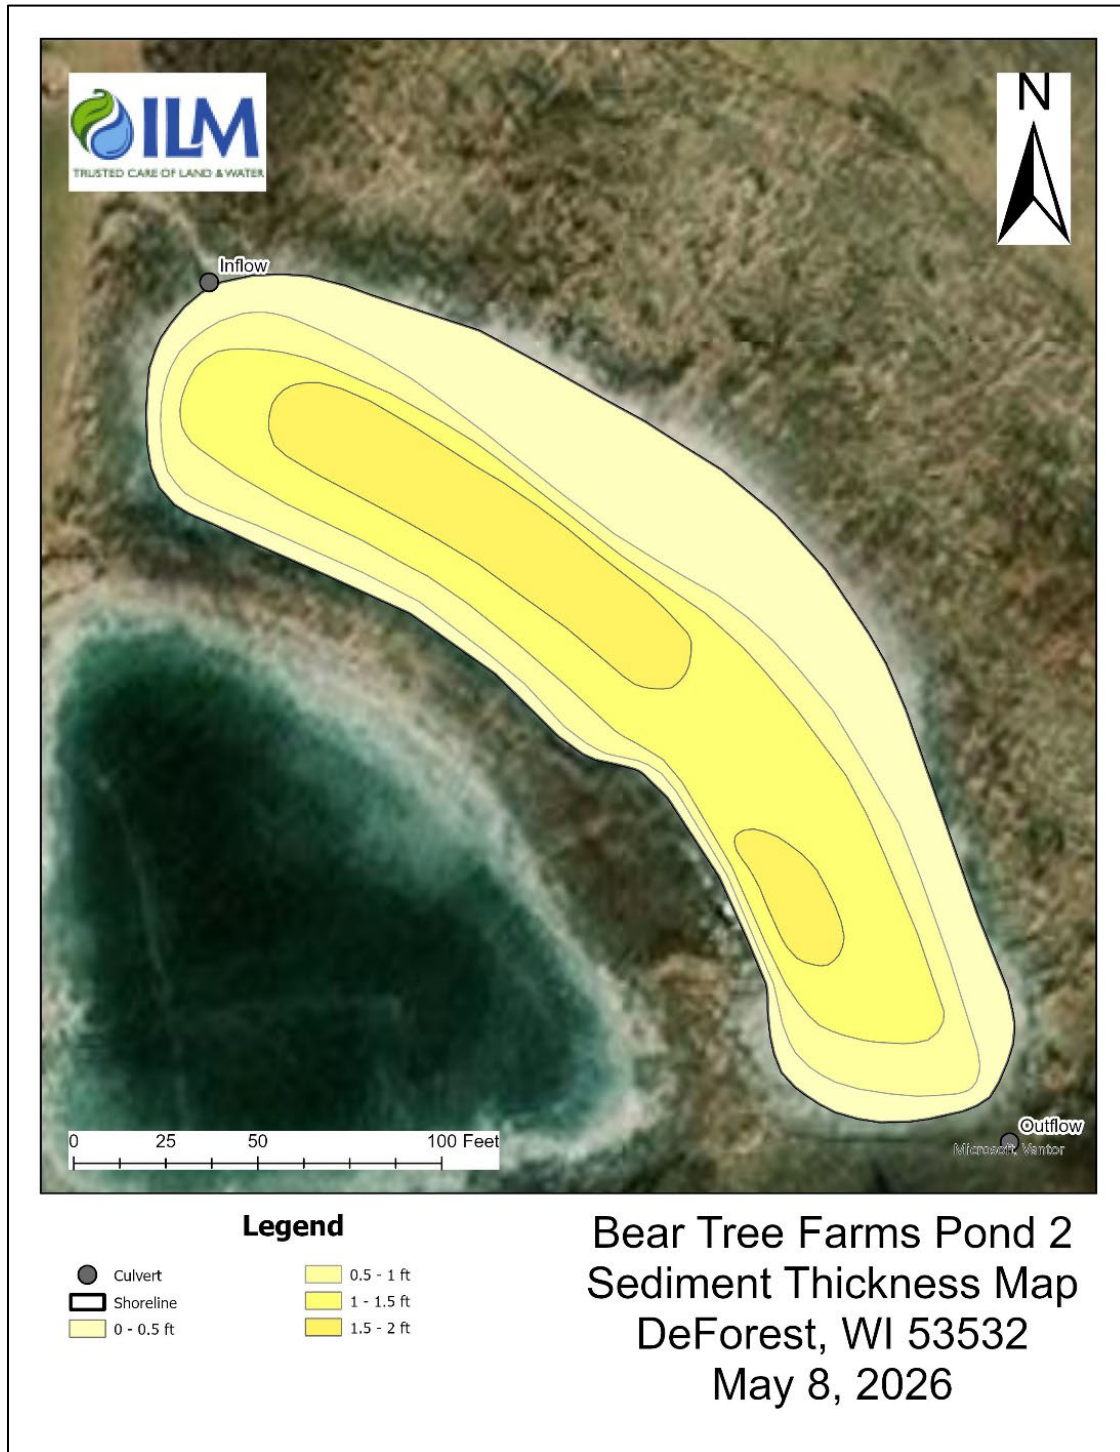
**Figure 6.** Sediment thickness survey map of Bear Tree Farms Pond 2

Bear Tree Farms Pond 2 is 29% full of sediment (Table 2). The maximum sediment thickness recorded was 1.8 feet. The average water depth was 2.4 feet. If the entire area were dredged of all sediment, around 378 cubic yards, the average water depth would increase by about 0.9 feet. This would increase the basin's volume by approximately 0.2 acre-feet, or 74,945 gallons at NWL.

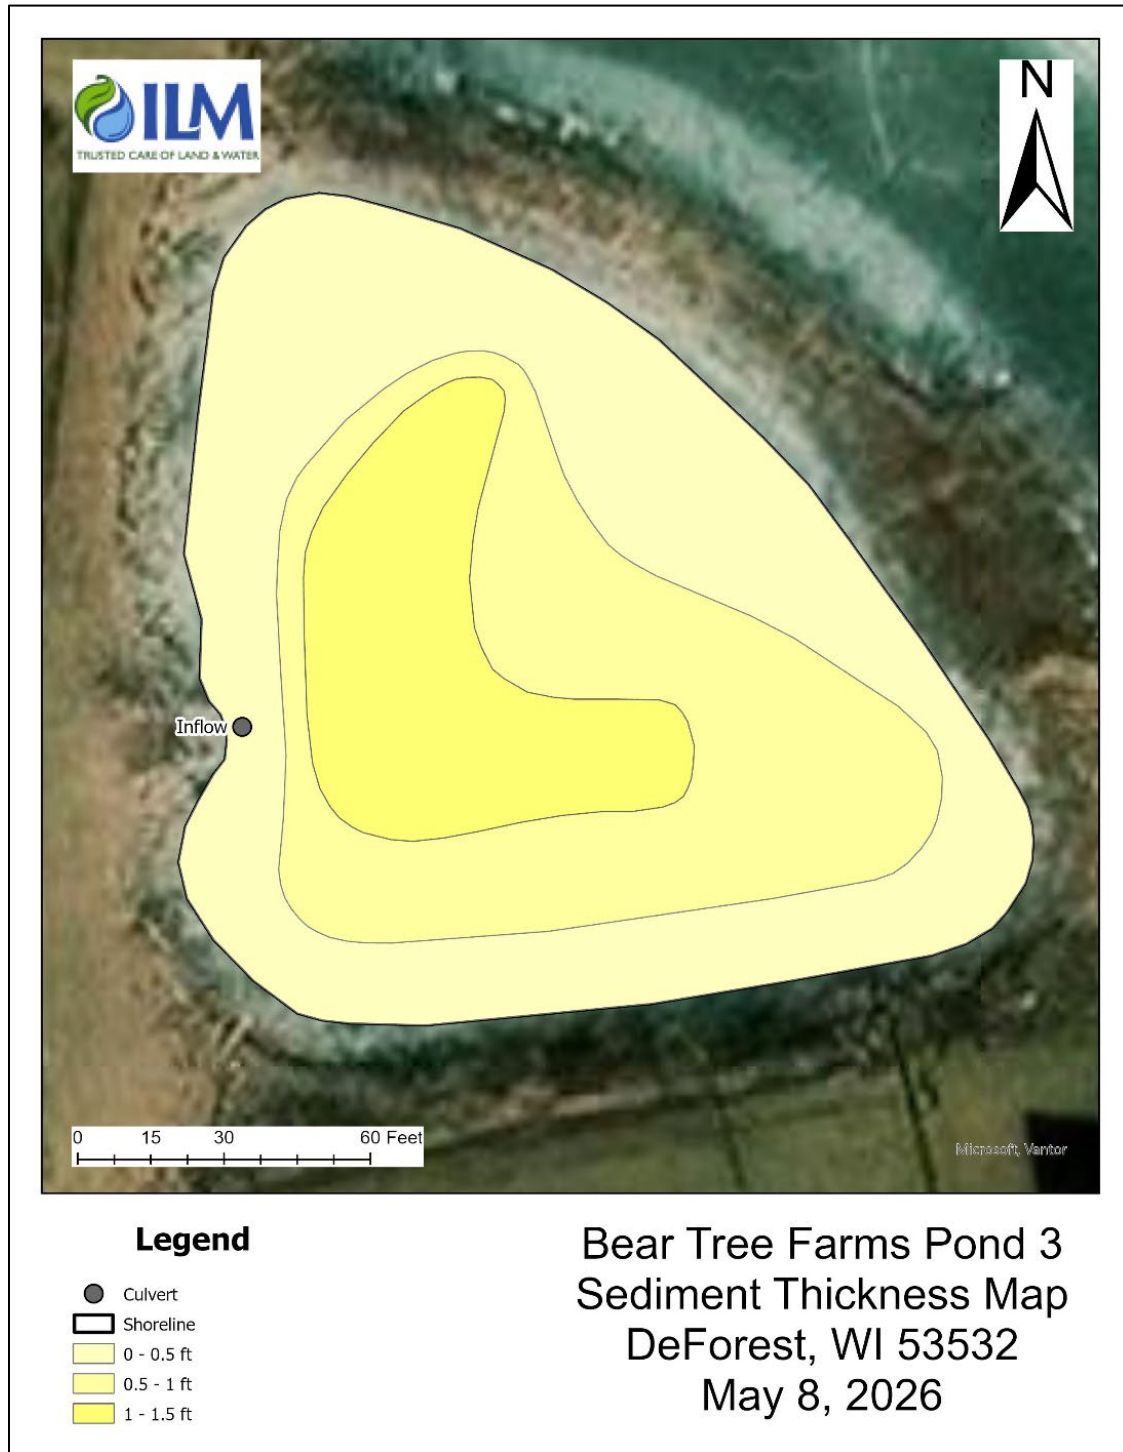
**Figure 9.** Sediment thickness survey map of Bear Tree Farms Pond 3

Bear Tree Farms Pond 3 is 16% full of sediment (Table 3). The maximum sediment thickness recorded was 1.3 feet. The average water depth was 3.5 feet. If the entire area were dredged of all sediment, around 250 cubic yards, the average water depth would increase by about 0.6 feet. This would increase the basin's volume by approximately 0.15 acre-feet, or 48,878 gallons at NWL.

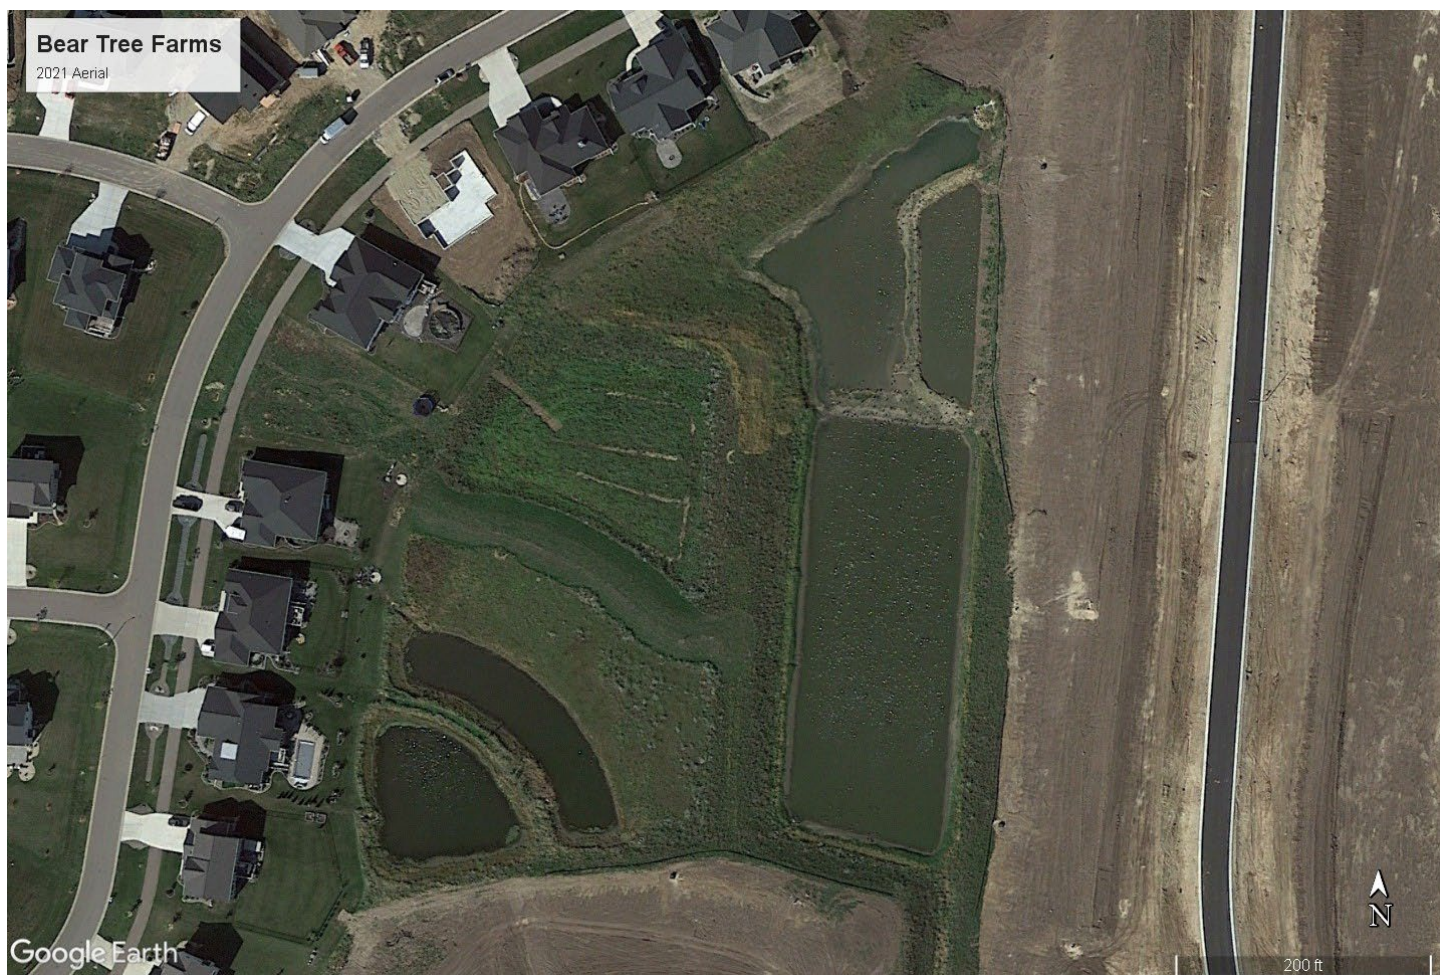
**Figure 11.** Pond 1 was separated into 3 distinct basins between 2020-2022. Source: Google Earth, 2021.
