# 2026 BEAR TREE FARMS SEDIMENT INVESTIGATION REPORT

PREPARED FOR:  
Bear Tree Farms HOA

PREPARED BY:  
ILM ENVIRONMENTS

June 09, 2026

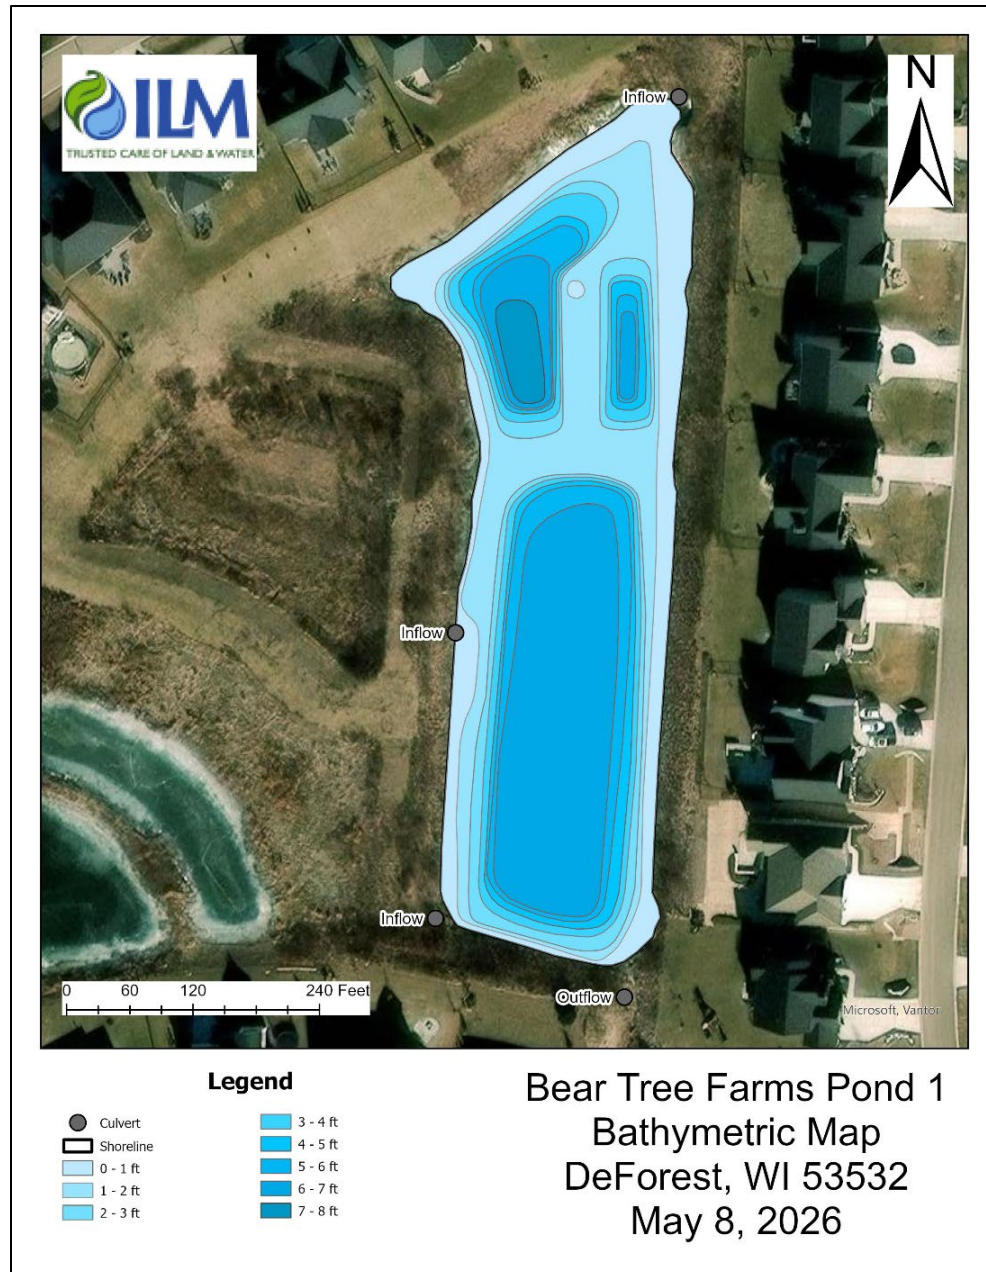
**Figure 2.** Bathymetric survey map of Bear Tree Farms Pond 1

This map represents the topography of the waterbody, using contour lines to indicate depth. Deeper areas are illustrated by darker coloring, while the shallower areas are lighter.

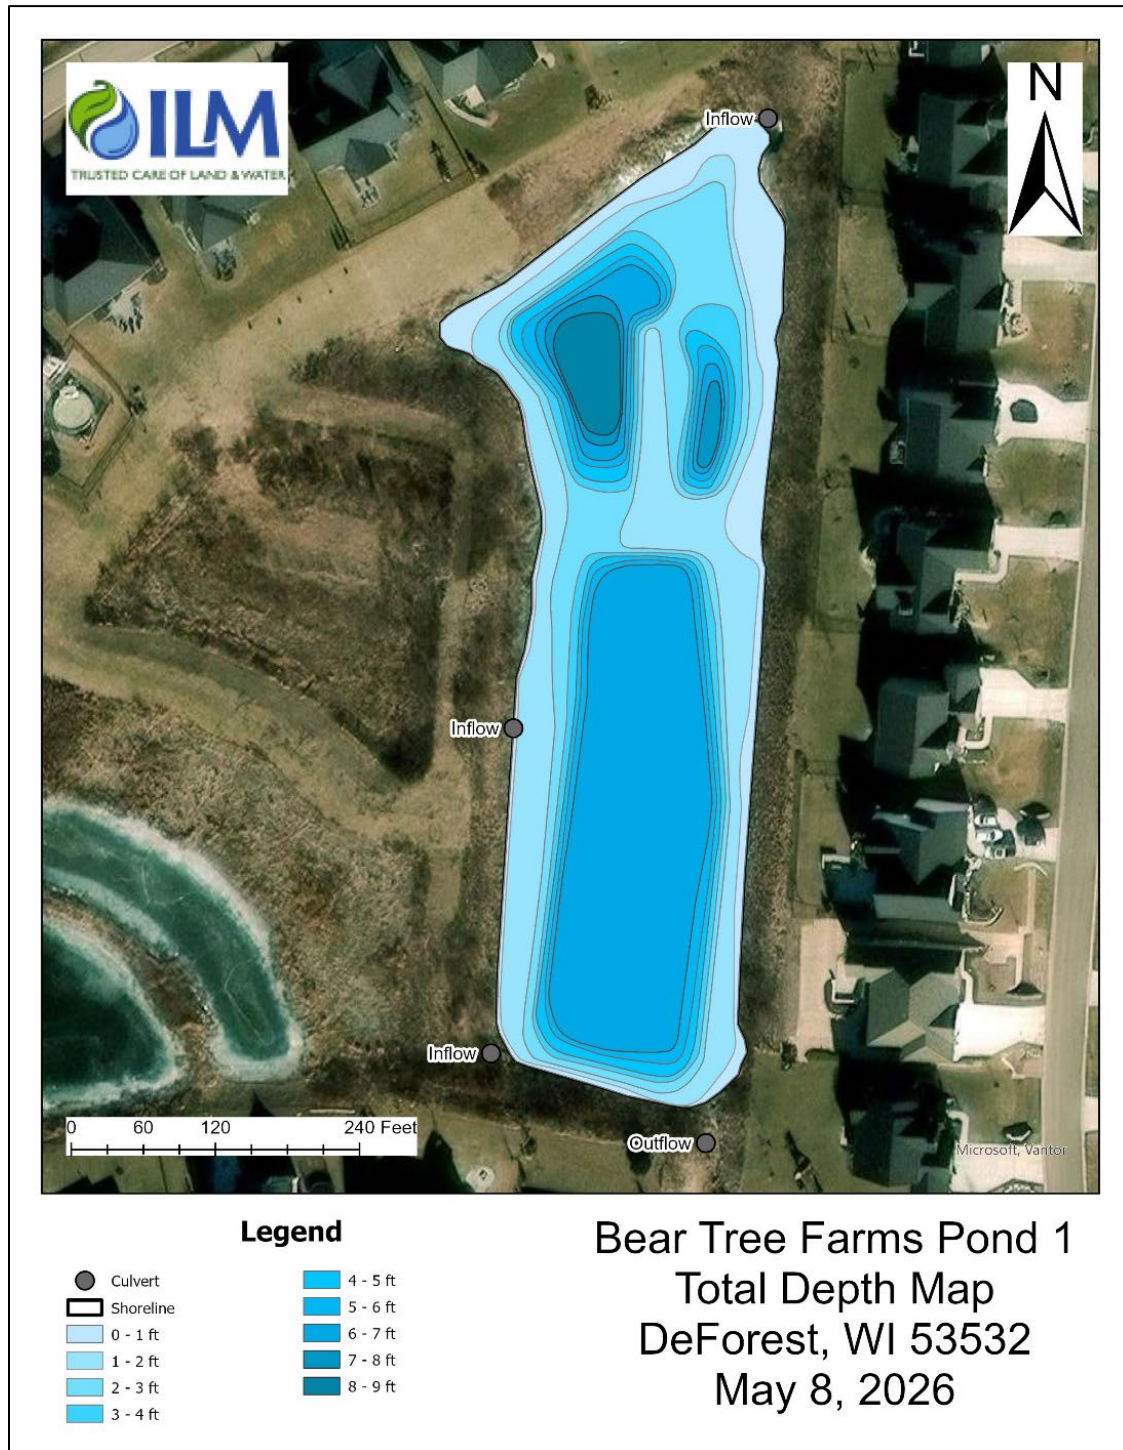
Figure 4. Total depth survey map of Bear Tree Farms Pond 1

This map combines data from the bathymetric map showing water depth and the sediment thickness map to show the depth from the surface of the water body to “hard bottom”. If all sediment present was removed, these numbers represent how deep the water body would be.

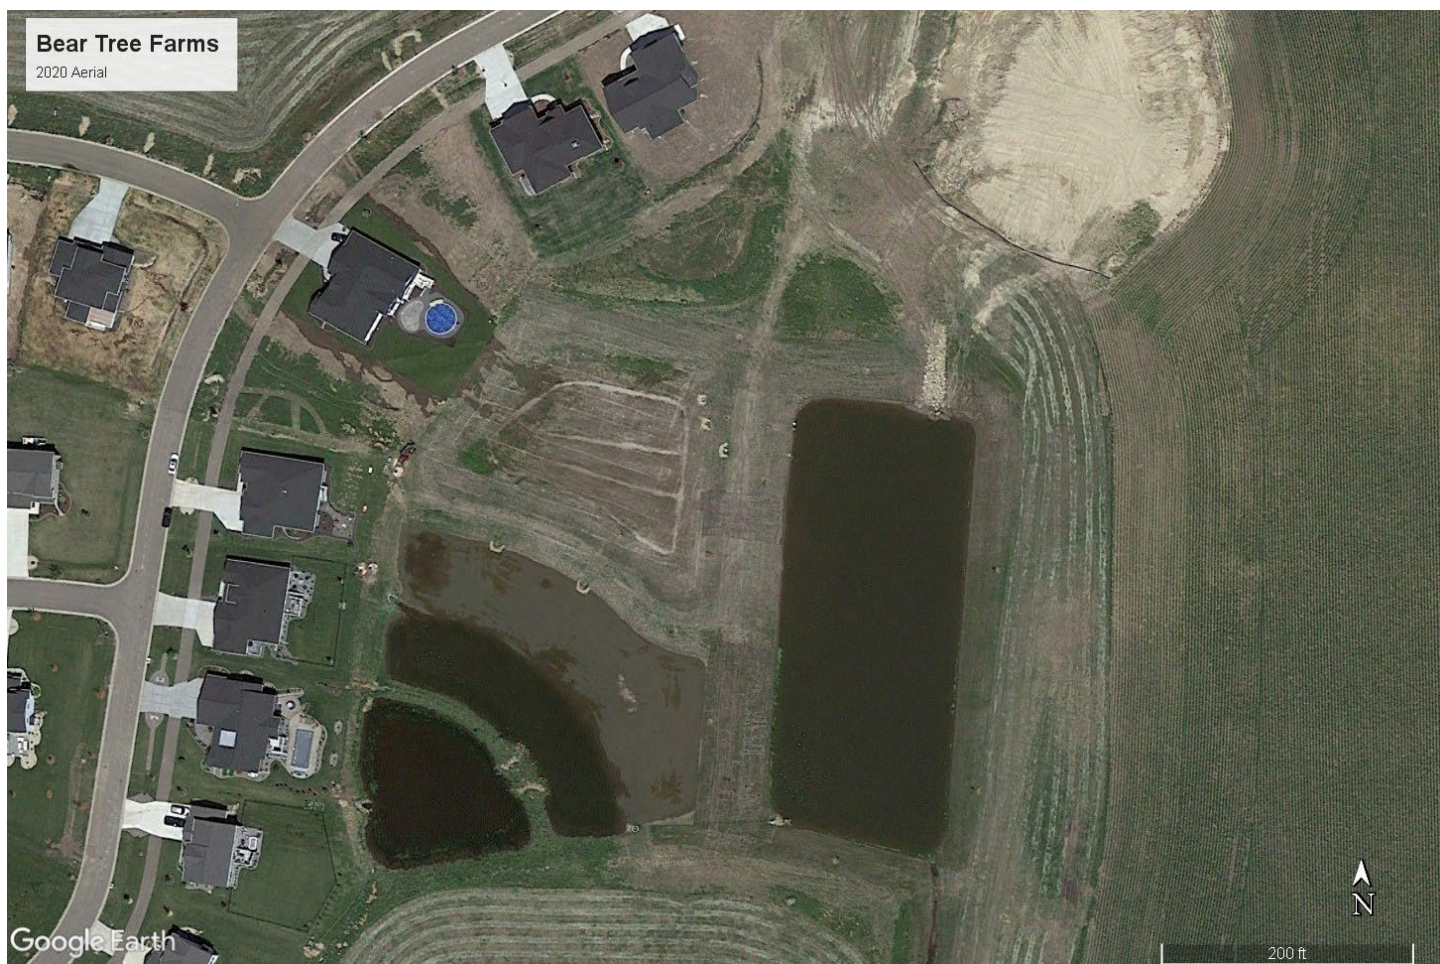
- A long compact sandbar extends from a projection of rocks on Pond 1. Historical imagery shows that this was a terrestrial separation during new pond installations in 2020-2021 before the ponds were filled into the single 1.9-acre basin that is currently present (Appendix C).

**Figure 12.** Pond 1 was smaller in 2020 before being expanded upon in later years. Source: Google Earth, 2020.

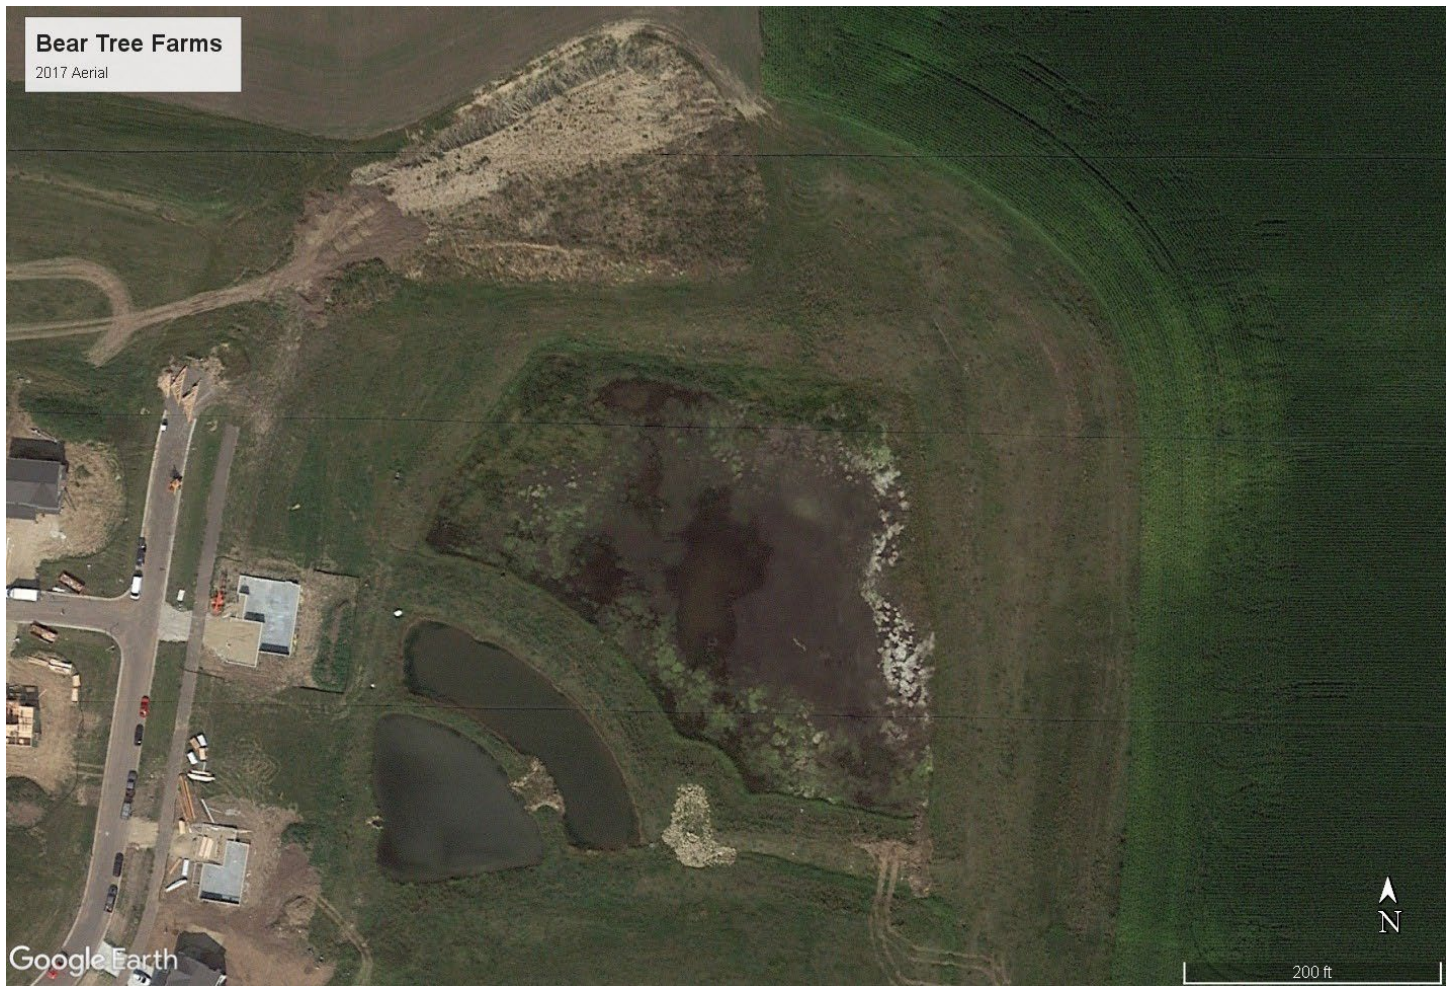
**Figure 12.** Ponds 2 and 3 were constructed first around a wetland depression that was later replaced with Pond 1. Source: Google Earth, 2017.
